Inspection Report

Mine Name: Hebe
Operator Name: Georgia Pacific

Permit number: M0150072
Inspection Date: April 11, 2007
Time: 3:10-3:30 PM

M0150072, Hebe Mine, Georgia Pacific

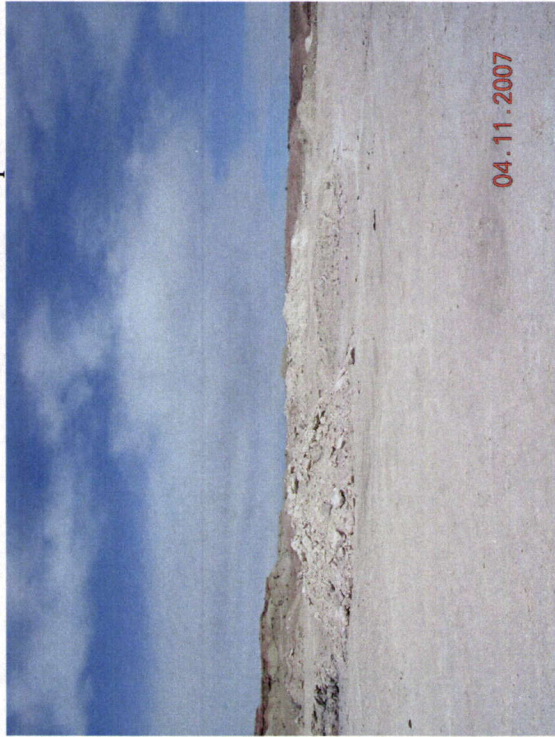
I could not tell that there had been any recent activity at the mine. Various views of the site are in Photos 1 through 4. Photos 1 and 3 and Photos 2 and 4 make panoramas.

Photo 1. This and Photos 2 through 4 show overviews of parts of the mine. Photos 1 and 3 and Photos 2 and 4 make panoramas.

If the operator is not going to mine this site, it should be reclaimed. According to annual reports, the mine was last active in 2002.
